The Conservation of the Mosaic Floor of Swaifieh Church, Amman, Jordan

This paper aims to describe the conservation of the mosaic floor of the Swaifieh church in Jordan, which is one of the few remaining byzantine mosaics in Amman region. The mosaic was discovered in 1970. Since then the mosaic floor has been exposed to the different deterioration forms such as lacunae, incrustation, depressions, swelling, detachment between preparatory layers, salt efflorescence, and biological activity. The study confirms that it is necessary to conserve the mosaic floor in order to avoid further damage.

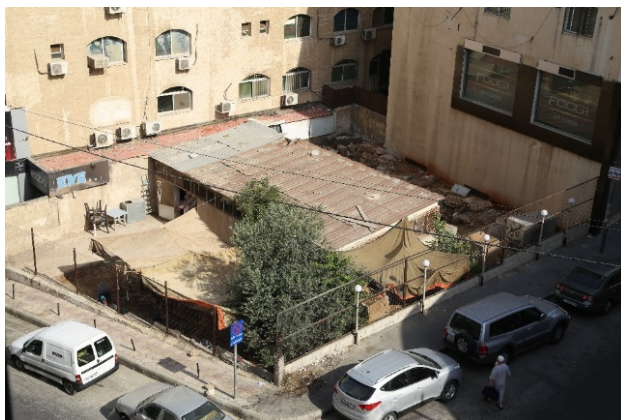
Figure 2. General View of the church with shelter

The mosaic covered the floor of a rather atypical byzantine church, which had a single internal chamber, rather than the usual arrangement of a nave separated from two side aisles by colonnades. Traces of structures along the north and west walls may have been rooms used by the clergy (Fig. 2) (Van Elderen, 1970).

The first activity to preserve the mosaic was conducted in 1970, the interventions include the edging repair with cement and restoring of lacunae through fillings with cement and randomly with original tesserae. In 1970, a new shelter was built over the mosaic. The shelter has been in position for about 47 years (Fig.2).

Because the shelter plates are noticeably old and require replacement. It was necessary to replacement the old plates with new one, to avoid rainwater from reaching inside the building.

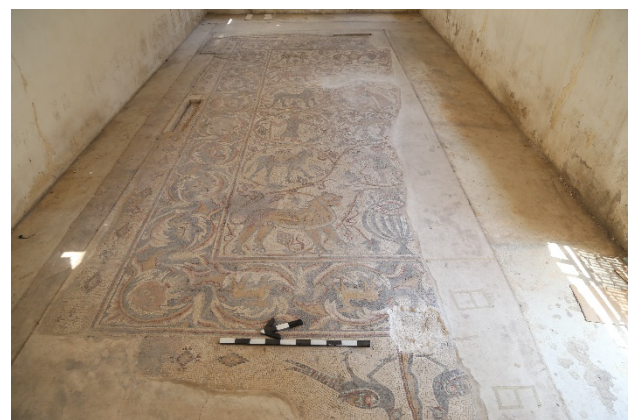
Figure 3.General view of the mosaic floor

Only the northern half of the mosaic floor is preserved. The outside measurement of the mosaic floor are almost 9.5 meters by 5 meters.

The rectangular field is surrounded by an acanthus border with foliate heads in the corner scrolls. The other scrolls are filled with a variety of birds and animals; these include two gazelles and a dog barking at a wild boar. A hare, a deer, a bull, guinea-hen and two aquatic birds are also depicted.

Within the border, two vine shoots issue from an amphora placed on the west side; six rows of vine scrolls fill the field. A fantastic wild beast faces the amphora. In the second row, a young man leading a donkey with a basket of grapes; in the third row, a bearded camel driver transports stones for construction. In the fourth row, a horned animal is showed near a shepherd leaning on his staff, and in the fifth row, there are a horse and a hunter with a bow in his hand. A gazelle facing an eagle with spread wings closes the composition to the east. The surround between the central carpet and the walls is decorated with floret crosses and diamonds. Outside the eastern border of the mosaic floor, a two line inscription mentions the name of Bishop Thomas. At the western end of the mosaic floor two pheasants face a tree. This appears to have been in the entrance of the church and a few stones of the threshold were found at the edge of the mosaic(Fig. 3) (Piccirillo, 1993; Azar, 1980; Van Elderen, 1970).

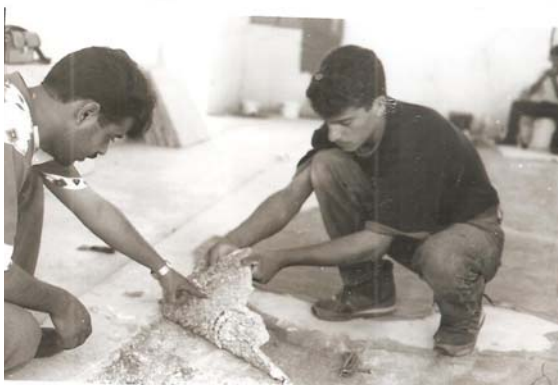
Figure 4. Lifting the mosaic (Hunaiti ,1995)

The mosaic was divided into sections. Two layers of textile were glued with PVA glue over the various sections of mosaic. The lifting was carried out using big chisels, hammers, and metallic pincers (Fig. 4). All the mosaic sections were numbered. After the lifting, the mosaic sections were located upside-down over wooden boards, in order to facilitate the cleaning of their back. After the cleaning of the back of the mosaic by chisels and hammers, the ancient mosaic layers were removed until arrived to the last layer (*statumen*) The relaying of the mosaic was carried out using mortar made of quartz, cement, and hydraulic lime in ratio of (1,5:1:1).The textiles over the mosaic sections, used to lift them, were then removed and the surface has been cleaned(Fig. 5) (Hunaiti ,1995).

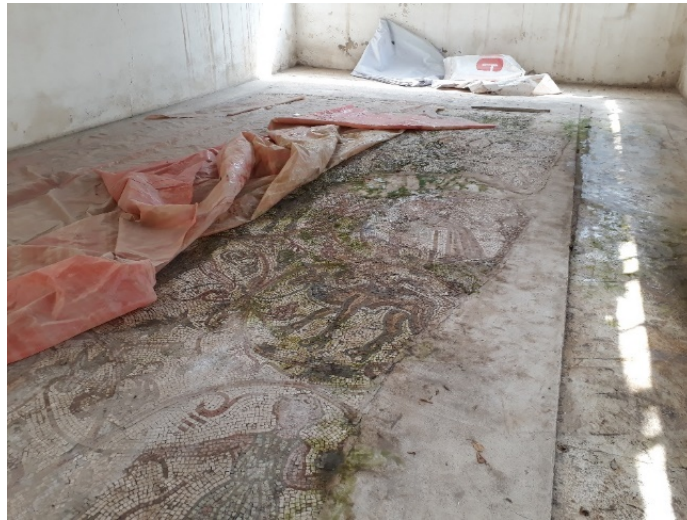
Figure 6.The plastic sheet over the mosaic

Nearly half of the mosaic was already lost before it was discovered, it could have been destroyed in antiquities. Also the mosaic floor its self was found covered by thin plastic sheet (Fig.6). Despite the protection, the mosaic floor suffering from various deteriorations forms. These deteriorations are presented in the next paragraphs.

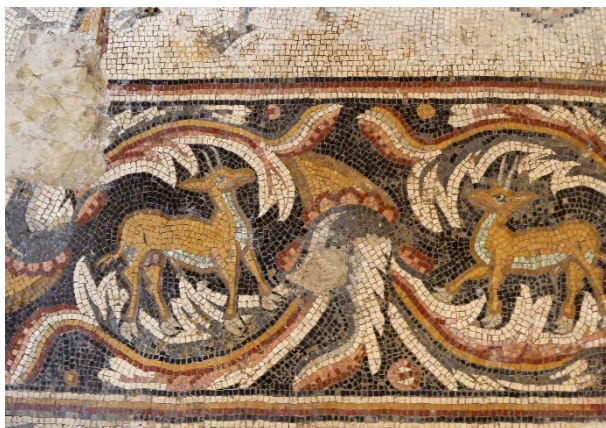
Figure 7.Lacuna filled with cement

The mosaic floor shows a number of lacunae in some areas of the mosaic were filled with black cement mortar to the level of *tessellatum* in the previous intervention(Fig.7). Moreover, areas which had been probably redone in the past were easily detected on account of the fact that the *tesserae* had been set without following the original *andamnato*(Fig.8).

The lacunae were treated by removing the cement which was used in the past interventions, and then the lacunae filled with mortar made of hydraulic lime, limestone powder and marble powder in 1:1:1 proportions (Fig.23). Before the use of mortar, a several of mortar samples in different ratio were prepared in order to select the appropriate one.

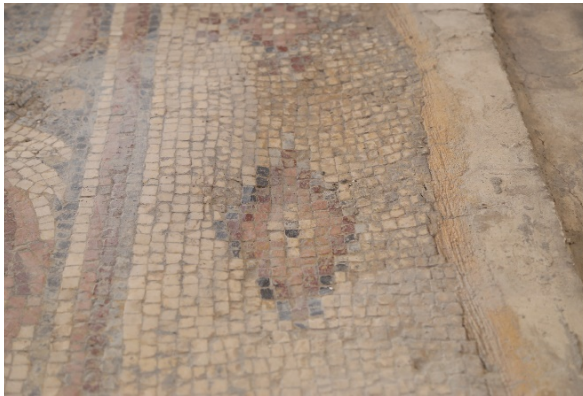
Figure 9. Depression

Only a few areas of the mosaic affected by the phenomenon of depression, especially in the northeast corner (Fig.9). The mosaic also affected by different forms of swellings, which concentrated in the area beyond the main entrance. This condition is associated with the new bedding layer in cement, which produced swellings and depressions.

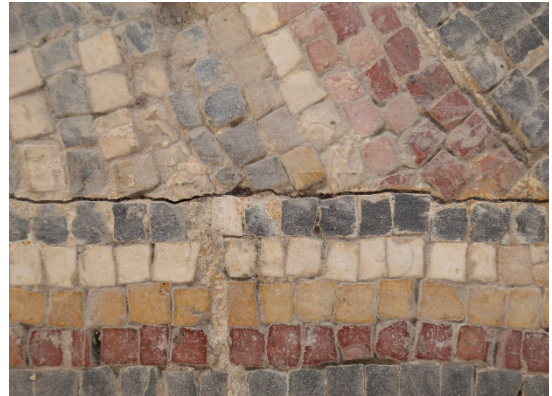
Figure 10. Cracks

Furthermore, various cracks are clearly visible in some areas of the mosaic surface, especially in the area near the Greek inscription, which may also penetrate into its bedding layer(Fig.10). Cracks can be induced by water infiltration and thermal expansion and contraction of the cement base into which the mosaic laid(Roby et al; 2010; GCI,2012).

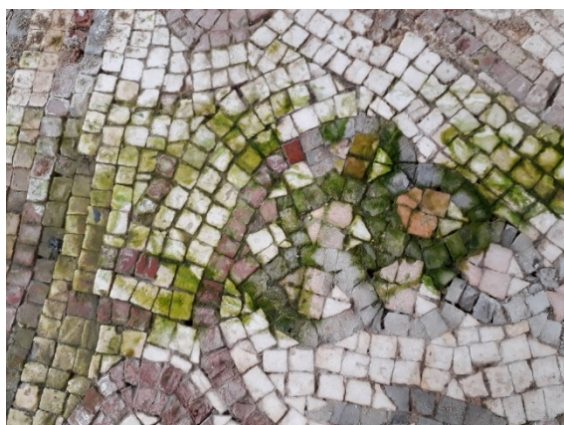
Figure 11. Microorganism

After the removing of the plastic sheet, green algae growth and white powdery salt efflorescence were evident on the *tessellatum* (Fig. 11 and 12). These phenomenon are associated with the percolation of rainwater coming from the roof. However, all of them were easily removable by hand tools, brushes and water.

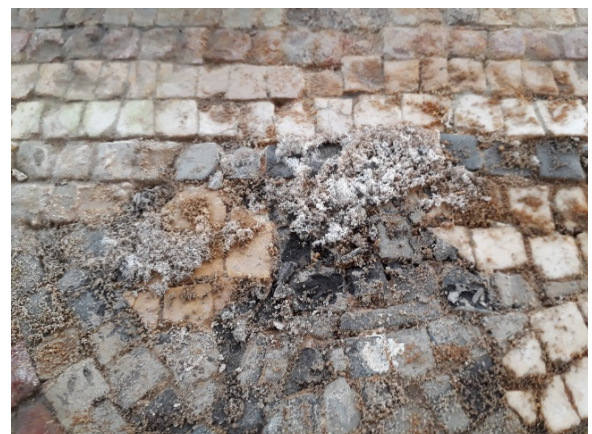
Figure 12. Efflorescence

Moreover, the salt efflorescence observed on the mosaic surface indicates that water is getting through the cement bedding layer and the fact that, salt crystalizes in the micr-cracks of the mortar and the tesserae, and with expansion leads to cracking and major damage to all layers of the mosaic. This occurs because of the ability of the cement to attract and retain moisture(Santopuoli et al; 2012; Zizola, 2008; Ugriyol, 2013).

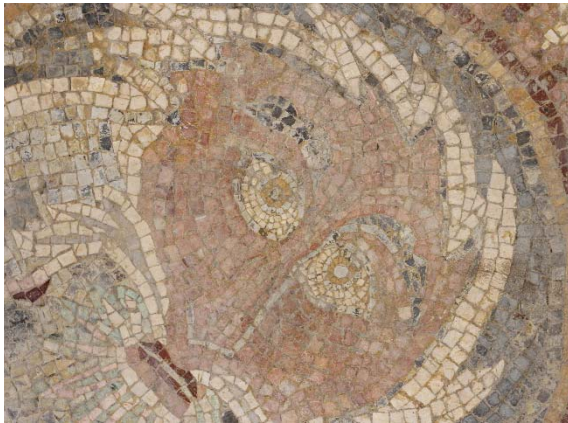
Figure 13. Incrustation

The whole mosaic surface was covered with different forms of incrustations (Fig. 13). Some of them were a thick hard white mineral crust, the others were in form of dirt and soil. Also there are some areas of the mosaic surface were obscured by black cement used in the previous interventions to fill the lacunae and to fix the border of the mosaic and was not cleaned. This greatly effects on the aesthetic of the mosaic (Fig. 14). This is result of poor workmanship during the relaying of the mosaic.

Mechanical cleaning with scalpels and small chisels were used to remove the incrustations. This operation has been carried out after wetting the surface with distilled water (Fig.21).

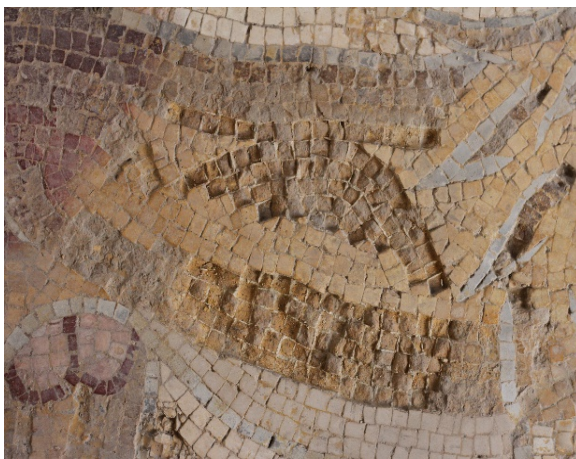
Figure 15. Tesserae deterioration(eroded tesserae)

Visual examination of the tesserae established various forms of deterioration such as fracture, exfoliation, pitting and eroding (Fig. 15). Moreover, permanent color alterations were also presented in some areas of the mosaic, especially in white tesserae, it was probably caused by ancient fire (Fig. 16).

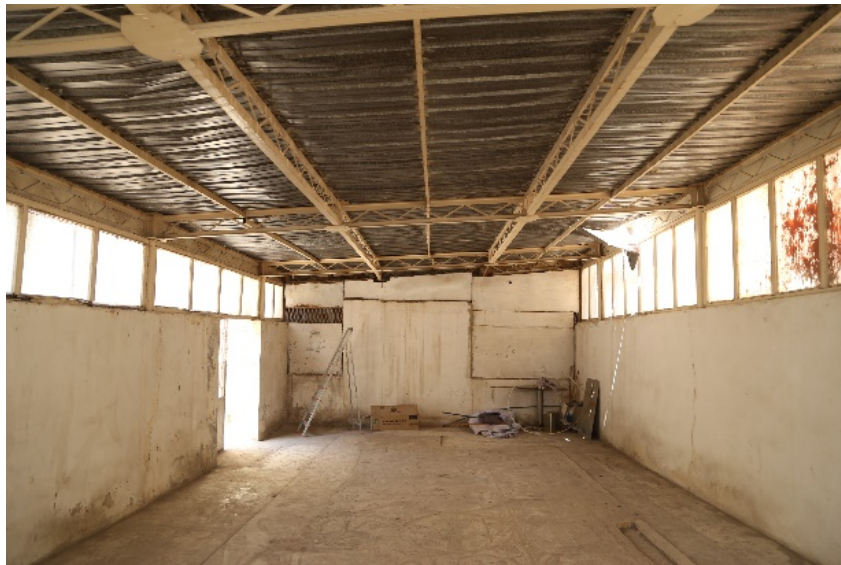
Figure 17. Holes and gaps in the roof

Most of these conditions are either directly or indirectly related to the water infiltrations from the current shelter. The holes and cracks are visible in many of the shelter plates(Fig. 17). This condition allows rainwater to infiltrate through into the mosaic. It was noticed a concentration of water in many areas of the mosaic especially in the southwest corner. Furthermore, the spaces and gaps between plates are sufficiently large to allow birds to enter to the building.

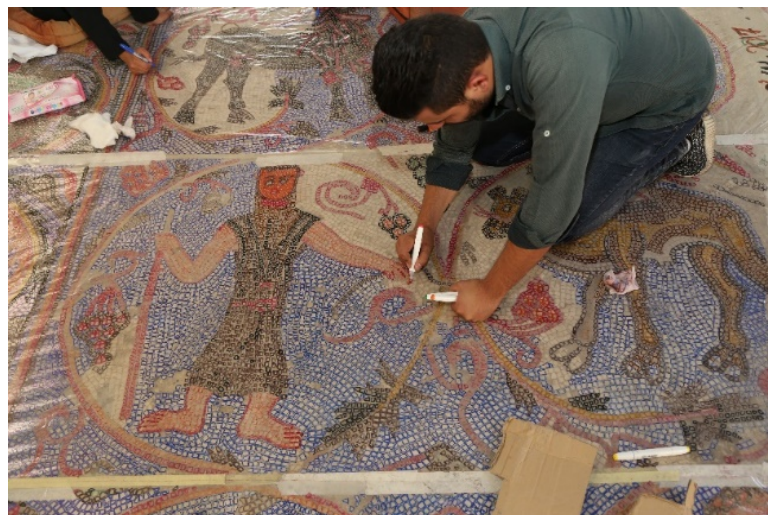
Figure 18. Documentation

For these purposes and after cleaning the mosaic surface by using just water and plastic brushers, the mosaic was photographed from the same height, square by square, and then re-assembling these photos using Photoshop in order to developing base map. All observed deteriorations and conservation steps were photographed and marked on this map. Also, the entire mosaic floor has been drawn on scale 1:1 over polyethylene sheets (Fig. 18). A general view of the mosaic was taken before and after conservation using digital camera (Fig. 19 and 20).

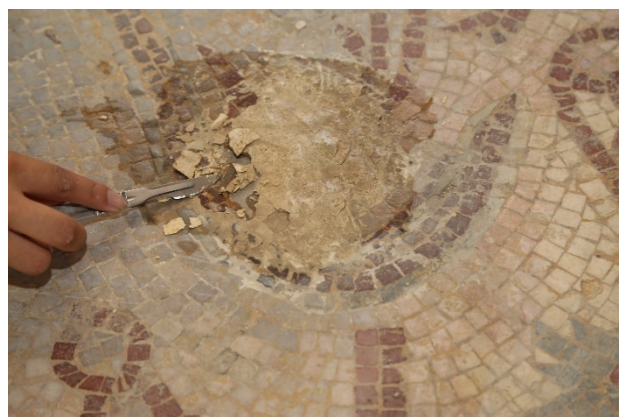
Figure 22. Cement removal with chisel and scalpel

To remove the previous restoration cement and mortar from the surface, mechanical method was used by light scalpel, chisels and a hammer (Fig.22). The operation started brushing up the mosaic surface with water to increase the hardness of the cement layer. For cleaning away the remains of the glue and the rust stains it was enough the use of blades.

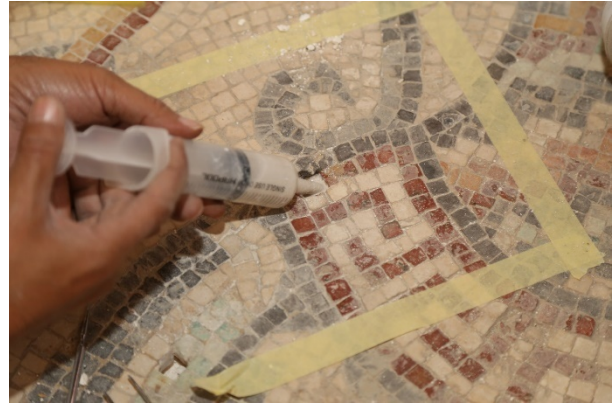
Figure 24. Consolidation by injection of lime mortar

Fluid mortar made of hydraulic lime, limestone powder and marble powder in ratio of 1:1:1 were used for this treatment.

The voids and the detached areas where detected and marked, then one or two tesserae where removed in order to create access points. Then a small hole was made using long slender chisels. The hole was wetted by injection a mixture of alcohol and water, and finally fluid mortar was injected using a syringe. The removal tesserae where put back in their original location (Fig.24).
